Date: May 24, 2021 Project Number: 19-009

Subject: 301 Mission Retrofit Monitoring Report 003: Results as of May 21, 2021

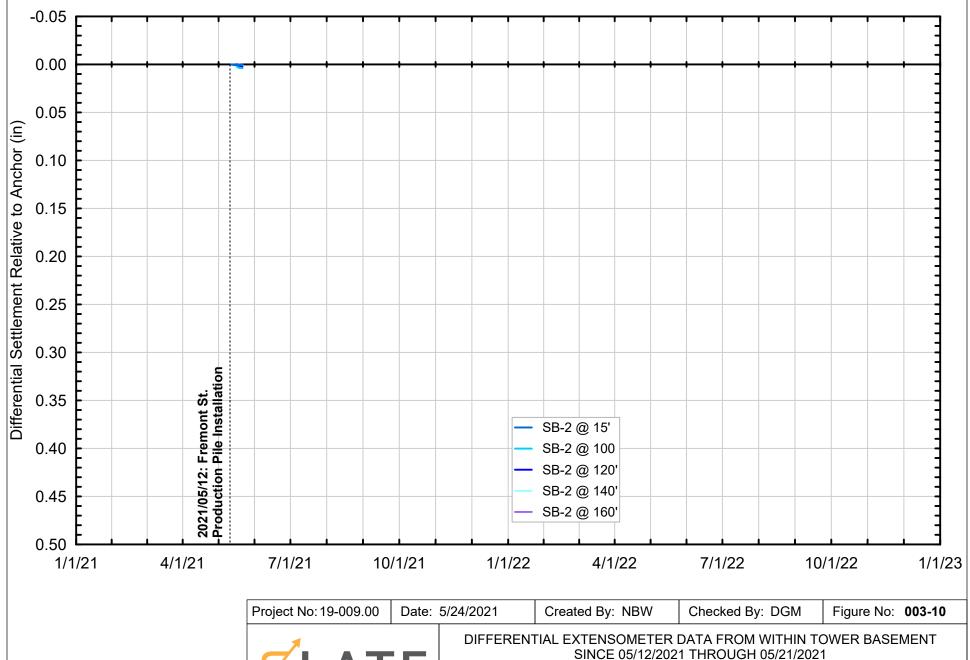
Figure 10 presents extensometer data from within the Tower basement since the start of production pile installation (May 12, 2021) through May 14, 2021. Figure 11 presents extensometer data from Fremont Street since the start of production pile installation (May 12, 2021) through May 21, 2021. Figure 12 presents extensometer data from Mission Street since the start of production pile installation (May 12, 2021) through May 21, 2021.
